**HYBRID DIESEL-ELECTRIC BUS / TROLLEY BUS  
DEMONSTRATION PROJECT:  
TECHNICAL COMPARISON OF IN-USE PERFORMANCE**

**APPENDIX B  
NOISE TESTING REPORT**

# Edmonton New Technology Buses Evaluation Project

## Noise Measurement Test Results: (Hybrids, Diesels & Trolleys) December 31, 2007

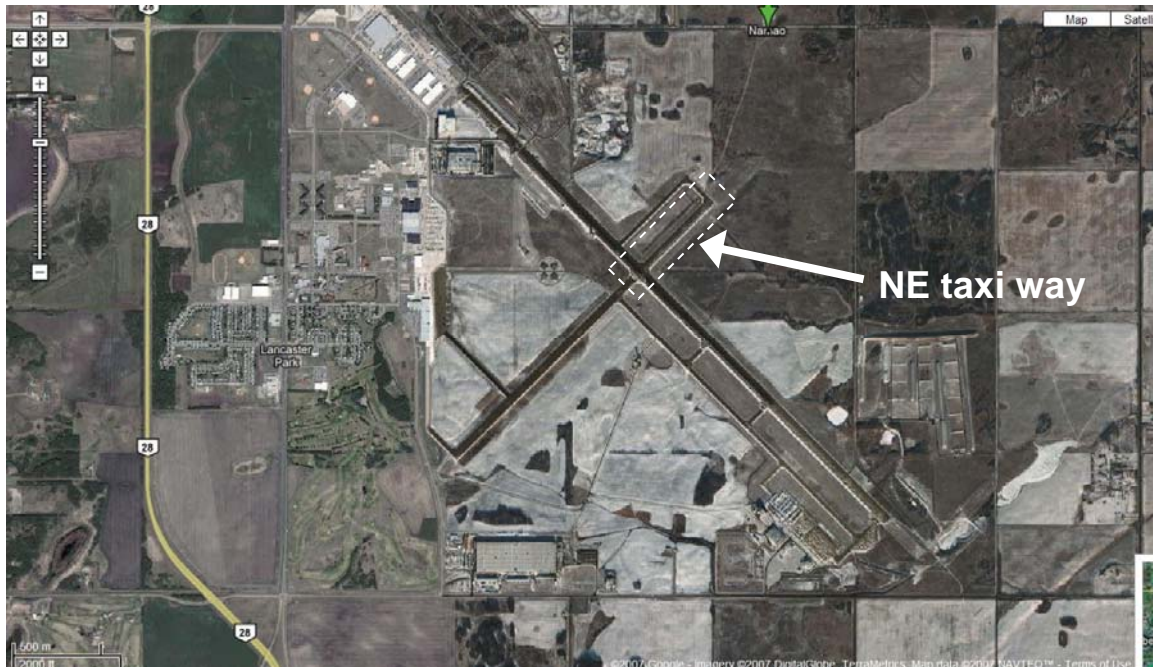
Figure 1. Satellite view of CFB Namao showing NE taxi way used for noise testing.  
Note that NE taxi way is approximately 600 m long and surrounded by flat agricultural fields.

The desired test surface for all SAE noise test procedures is a highly reflective uniform asphalt plane surrounded by an extensive open space to prevent echoes and sound distortion. The first set of tests was performed at CFB Namao, on the north-east taxi way off the main runway, (see Figure 1 below). This site provided a suitably flat, open surface surrounded by open fields. Background exterior noise levels were typically 30 to 40 dBA which is considerably below the noise levels recorded with a bus present.

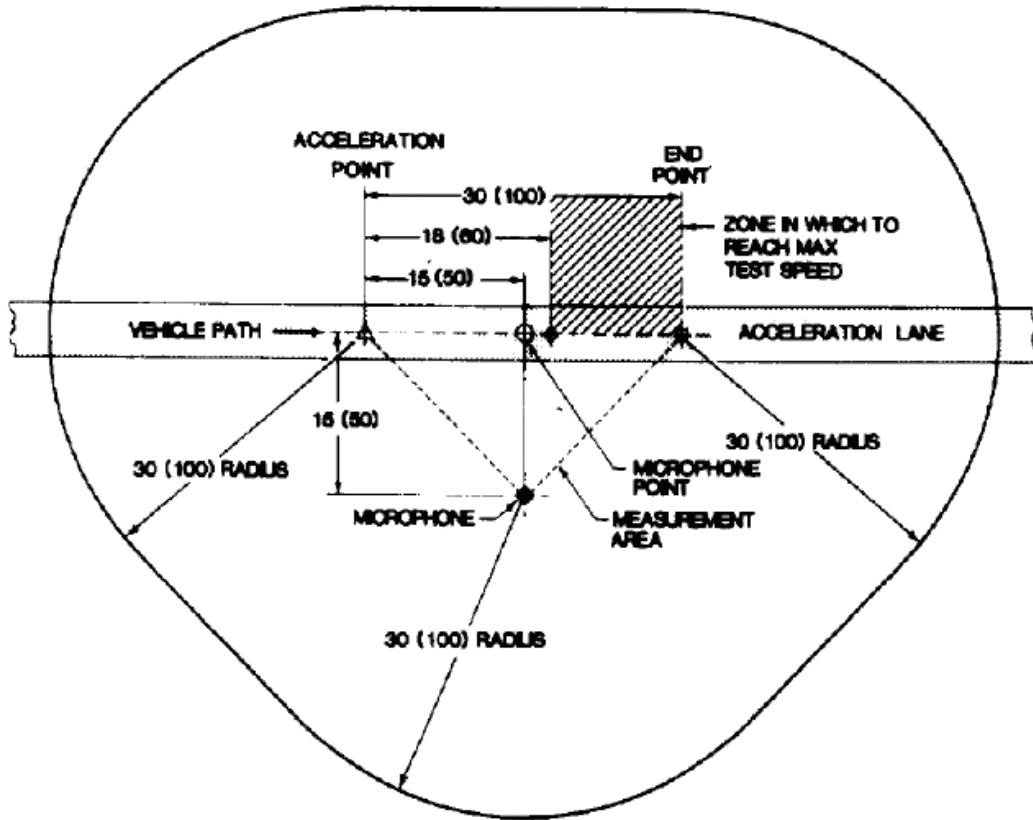
NOTE: DIMENSIONS ARE m(FT)

Figure 2. Test lane specified for SAE vehicle noise testing, (eg [1] to [6]), is a straight lane 30 m long with an external microphone 15 m to one side and 1.2 m (4 ft) above the asphalt.

The ideal noise test lane has a 30 m clearance from any noise-reflective walls or surfaces and allows for a microphone position 15 m to one side of the lane, which is also 30 m from any reflective surfaces, (as shown diagrammatically in Figure 2)

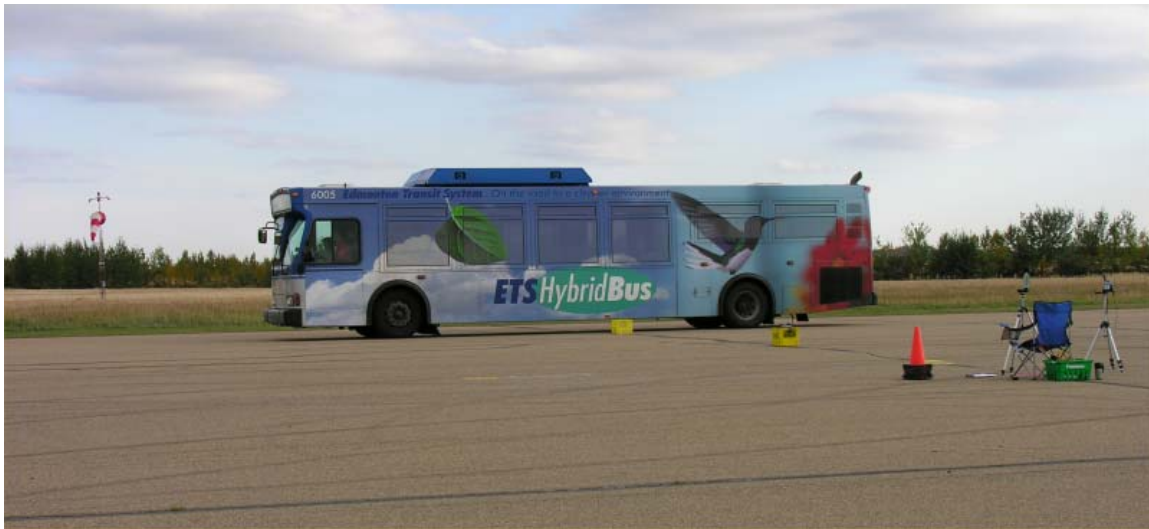
Figure 3. Hybrid Bus 6005 located at centre of test lane, 15 m from external observer station with sound level meter, anemometer and thermometer.

At Namao, a test lane was set up near the middle of the taxi-way length and close to the South-East edge of the taxi-way, as shown diagrammatically in Figure 3. This test lane was marked by cones to position the bus at repeatable locations relative to the external microphone for idle, acceleration, deceleration and cruise-by noise level testing. Wind speed and air temperature were also monitored at the external microphone site. A high speed acceleration run used the full length of the taxi-way (approximately 600 m) for acceleration runs to speeds around 80 km/hr and subsequent deceleration.

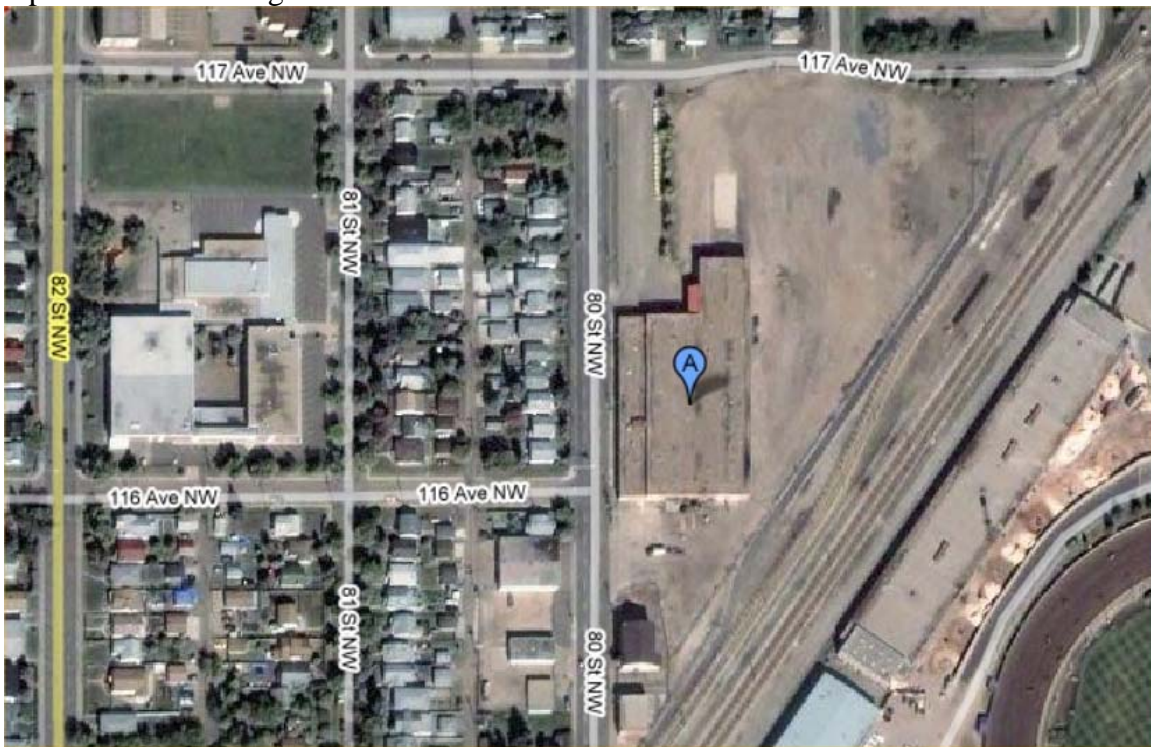
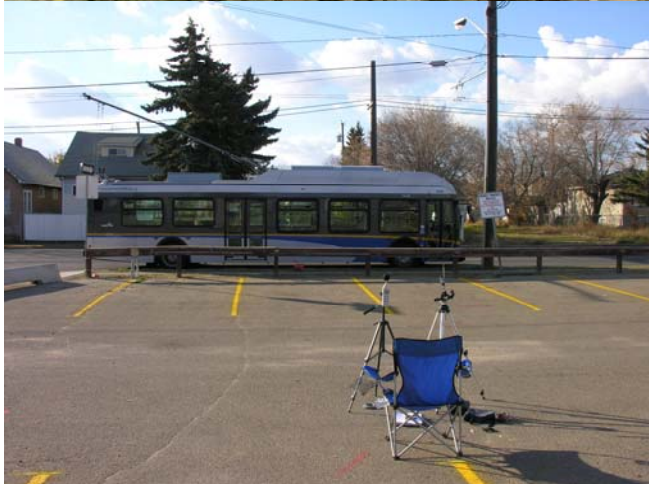
Figure 4. Cromdale noise test site.

Finding a noise test site for trolleys involved searching for a suitable length of street equipped with trolley wires, which could be shut down for testing and which had suitable clearance from noise-reflective surfaces. The chosen site was on 80<sup>th</sup> Street immediately North of Cromdale bus garage. The required clearances were obtained, (marginally) due to a break in the houses on the West side of the street and a parking lot on the East side of the street. The exterior test location was located in the parking lot 50 feet (15 m) from the curb location and traffic was blocked off the block between 116<sup>th</sup> and 117<sup>th</sup> Avenues for a short period. At this location, background noise levels were generally below 50 dB but there were periodic disturbances from other traffic and some test runs needed to be repeated due to background noise

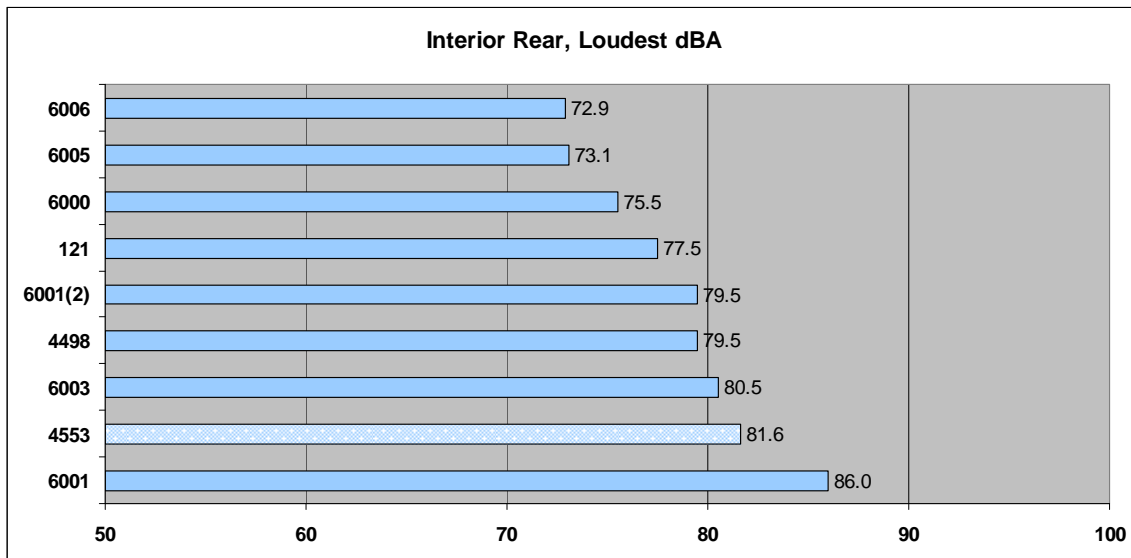
Figure 4.1a Comparison of loudest test mode noise levels at the interior rear position.

Interior Rear, Max	
	Loudest Result dBA
6001	86.0
4553	81.6
6003	80.5
4498	79.5
6001(2)	79.5
121	77.5
6000	75.5
6005	73.1
6006	72.9

The two Orion BAE buses (6005 and 6006) were the quietest buses. The New Flyer / Allison hybrid (6001) was the noisiest when it was tested in an area with higher speed. The other diesels and hybrids fell fairly close together at 79.5 to 81.6 dBA. The trolleys fell between with 75.5 dBA (for 6000) at the rear seats. Since a difference of 3 dBA is generally considered quite significant, the wide range of noise levels (ie. 13 dBA or a range from 73 dBA to 86 dBA) is a very significant difference in peak noise level at the rear passenger seats.

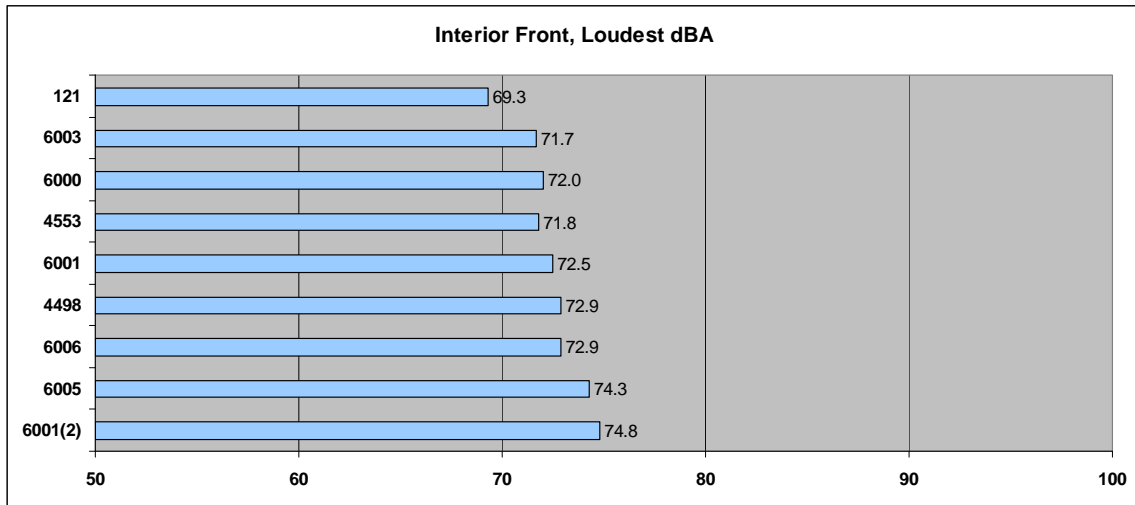
Figure 4.1b Comparison of loudest test mode noise levels at the interior front position.

Interior Front, Max	
	Loudest Result dBA
6001(2)	74.8
6005	74.3
6006	72.9
4498	72.9
6001	72.5
4553	71.8
6000	72.0
6003	71.7
121	69.3

Since drivers spend a lot of time in the bus, the loudest noise level at the front of the bus is also important. Figure 4.1b compares these results and shows that the difference between buses is much smaller at the front of the bus. Here, the primary noises are fans and the old trolley (121) has an advantage with less powerful / noise windshield fan. The other buses all fall very close to one another (within 3 dBA).

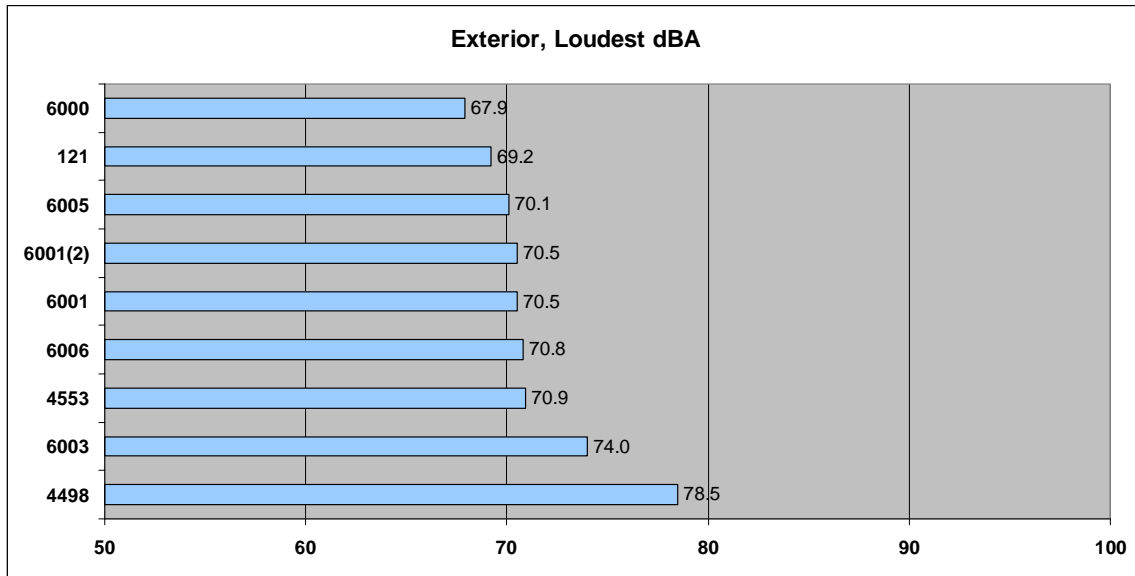
Figure 4.1c Comparison of loudest test mode noise levels measured from the exterior.

Exterior, Max	
	Loudest Result dBA
4498	78.5
6003	74.0
4553	70.9
6006	70.8
6001	70.5
6001(2)	70.5
6005	70.1
121	69.2
6000	67.9

From the outside, most of the buses had virtually identical peak noise levels of 70-71 dBA. The exceptions were the 6003 (New Flyer ISE hybrid) at 74 dBA and the 4498, (New Flyer 2006 diesel bus). At 78.5 dBA, it was substantially noisier in accelerating away from stops than any of the other buses. This illustrates the benefits of diesel filters and assistive hybrid systems. However, the trolleys were the quietest with only 68dB for the new trolley.
